# **MECHANICAL PROPERTIES AND FRACTOGRAPHY OF ELECTROSLAG REMELTED 300M STEEL**

**ALBERT A. ANCTIL**  
METALS RESEARCH DIVISION

March 1983

ARMY MATERIALS AND MECHANICS RESEARCH CENTER  
Watertown, Massachusetts 02172

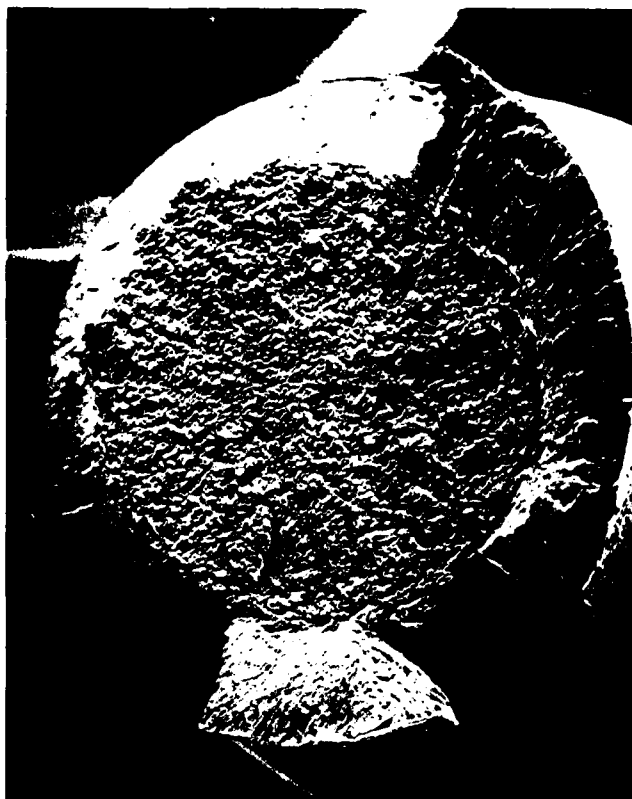
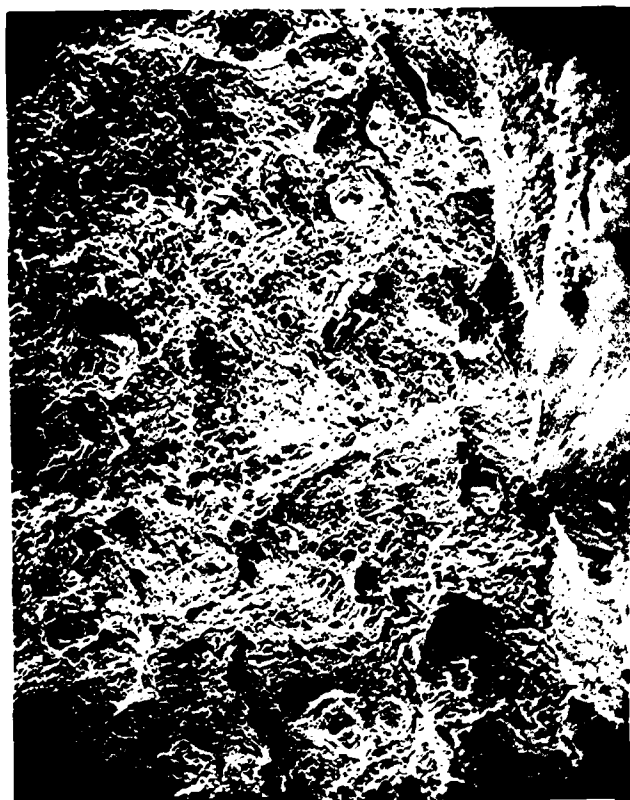
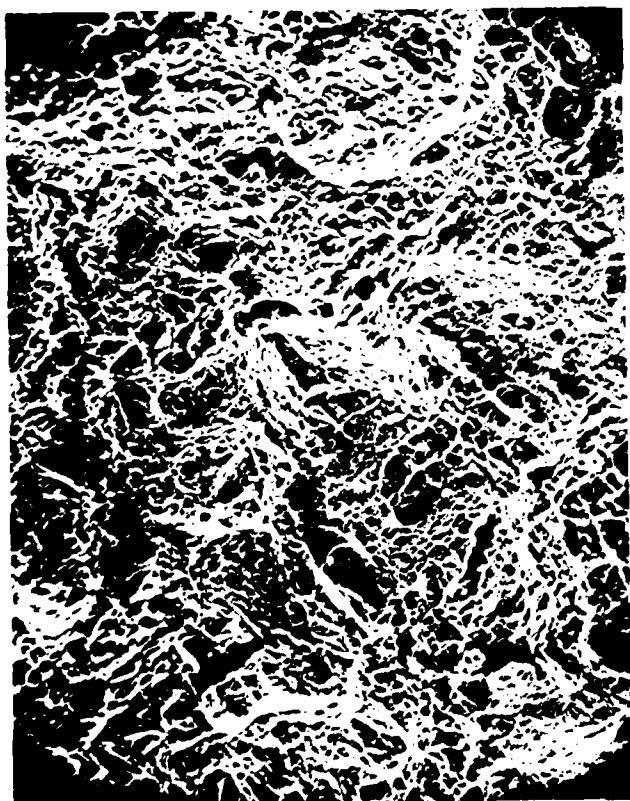
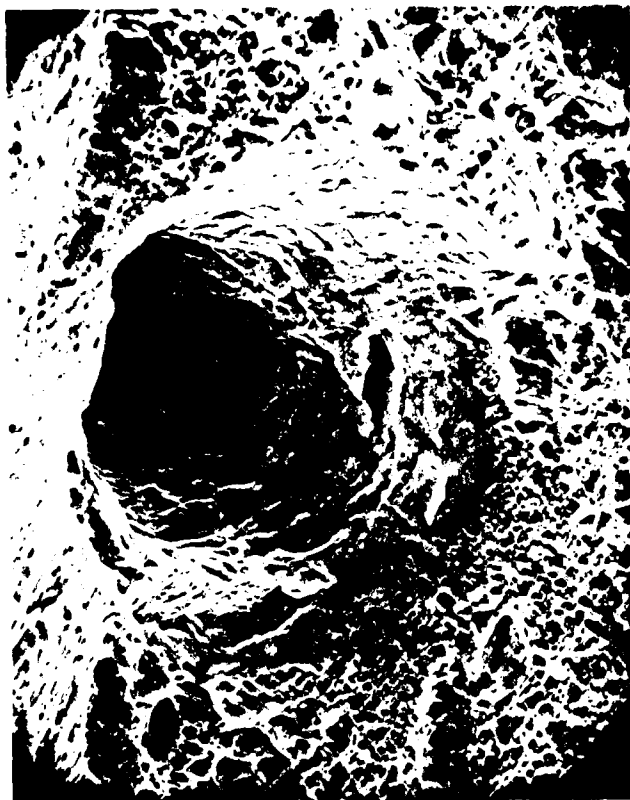
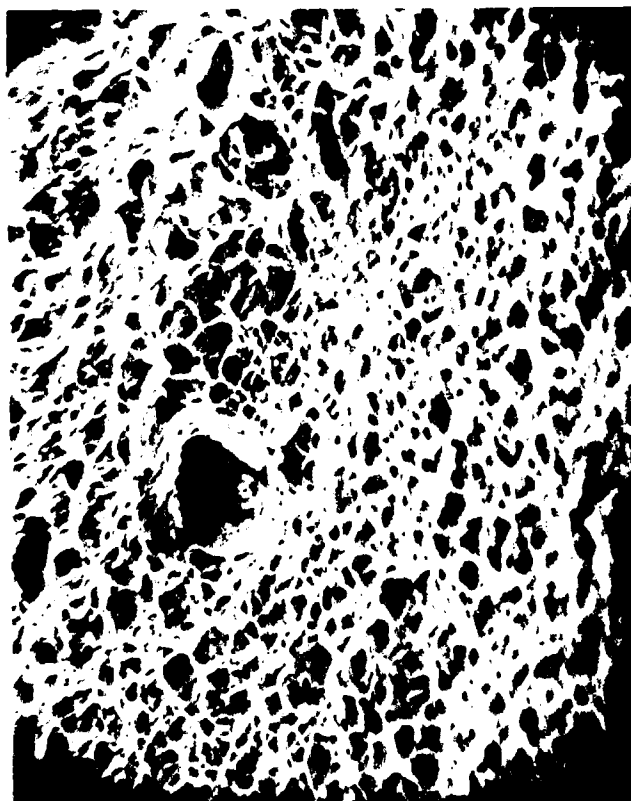
Figure 2. SEM longitudinal  
tensile fractographs.  
ESR 300M, longitudinal.

The longitudinal tensile fracture surface shown in Figure 2 has a full shear lip. The fracture mode is predominantly dimpled rupture. Typically, the fracture surface has a rough appearance (Figure 2a). Secondary cracking is observed along the tensile axis (Figures 2b and 2f). MnS cleavage planes can be seen in Figures 2b and 2d. Large voids, nucleated by MnS inclusions, were seen. One such void, surrounded by dimpled rupture, is shown in Figure 2e. A SEM photograph of the shear lip (Figure 2g) shows a fine network of elongated dimples with the presence of larger voids.

Typical tensile fracture surfaces from the longitudinal, long transverse, and short transverse orientations were examined under the scanning electron microscope (SEM). Figures 2, 3, 4, 5, and 6 show a macroscopic photograph of the tensile fracture surface and the SEM areas examined. The stringers mentioned in the following discussion were identified as manganese sulfides (MnS) by the SEM EDAX spectrometer. The traces are shown in Figure 4k.

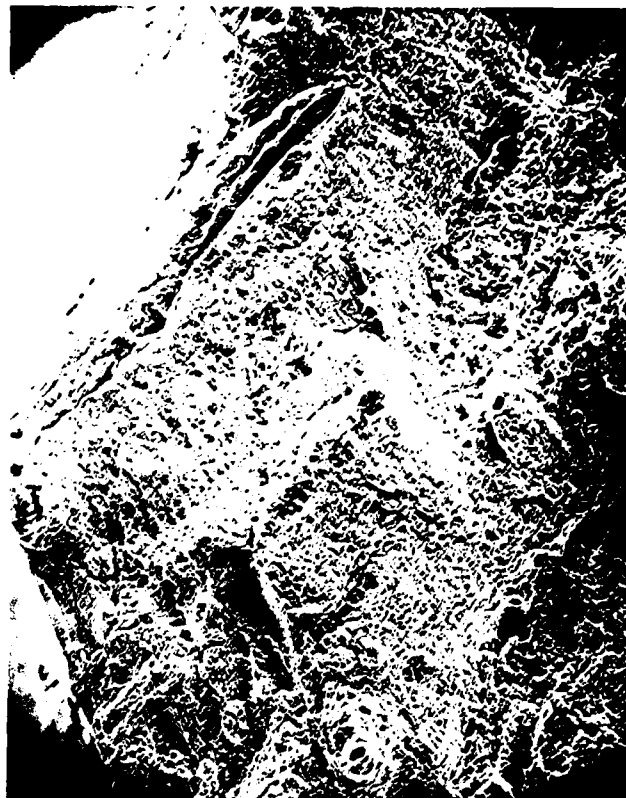
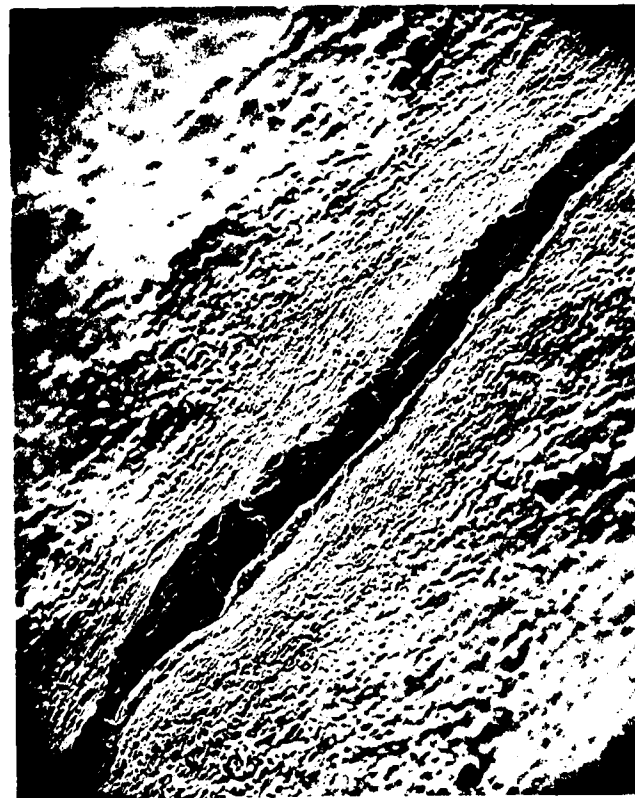
Figure 3. SEM long transverse tensile fractographs. ESR 300M, long transverse.

The long transverse tensile specimen failed in a ductile cup and cone fashion. The surface reveals a textured pattern corresponding to the major working direction of the forging. Shear planes extending into the long transverse direction can be seen in Figure 3e. These shear plane fractures may have been initiated by MnS inclusions (Figure 3b). Manganese sulfide troughs, some still containing sulfide particles, can be seen at various locations on the fracture surface (Figures 3a, 3b, 3c and 3d). Elongated dimples (Figure 3g) and a uniform change in the fracture plane (Figure 3h) were observed on the shear lip.

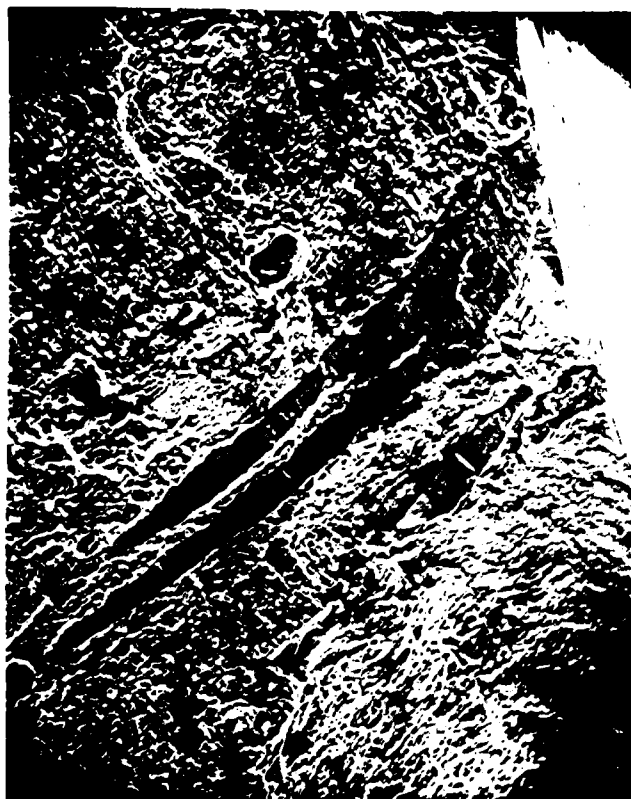
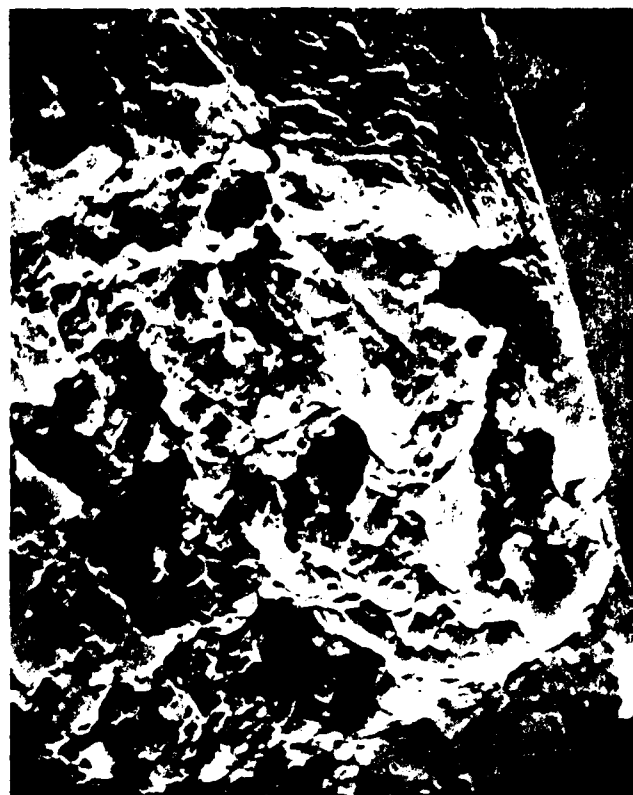
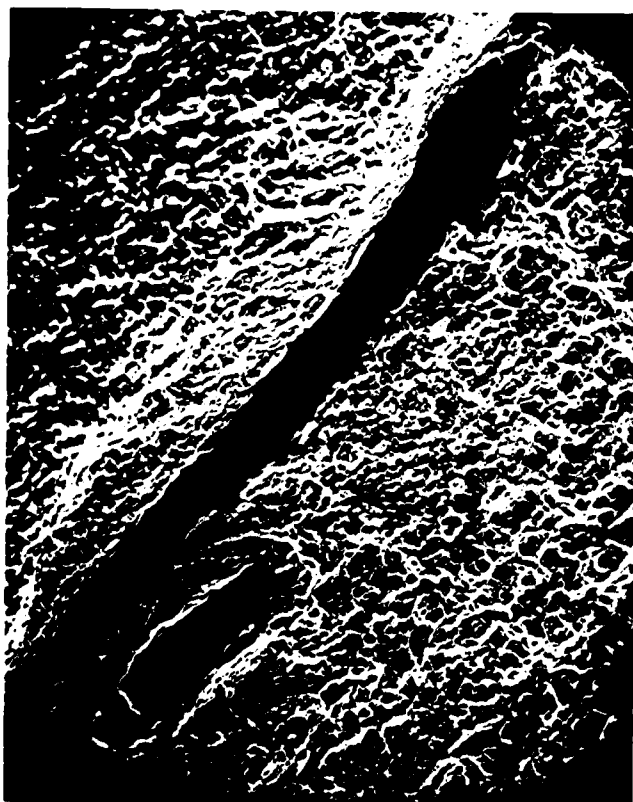
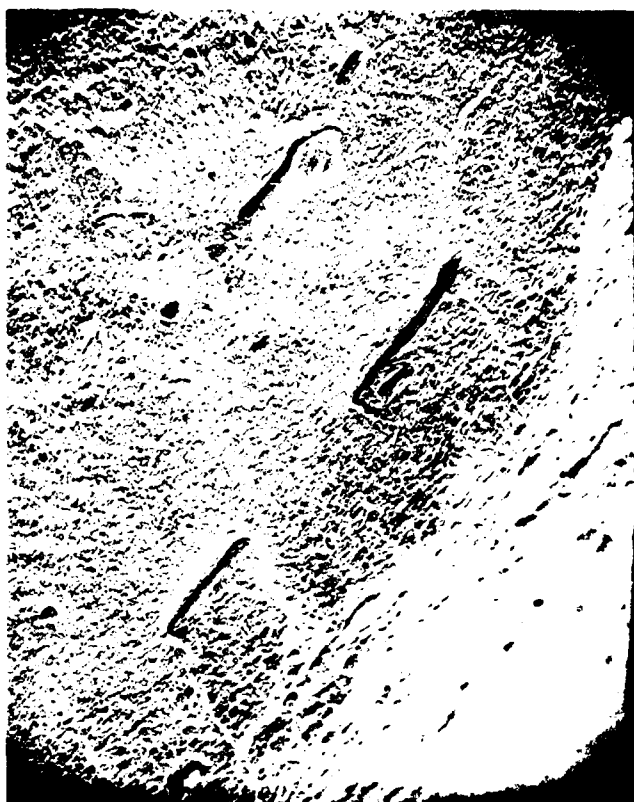
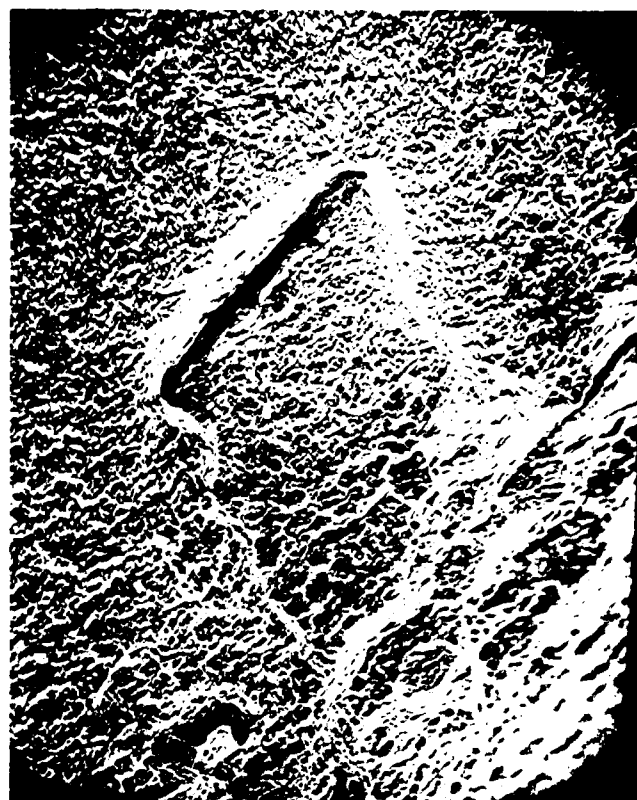
Figure 4. SEM short transverse tensile fractographs - heat treated in air. Short transverse.

The tensile fracture in the short transverse orientation for material heat treated in air and having poor ductility developed a nearly continuous ductile shear lip (Figure 4). It also has a textured appearance. The fracture origin was located at the intersection of a MnS inclusion with the specimen surface (Figure 4a). The structure shown in Figures 4b and 4d, taken close to the fracture origin, is quasi-cleavage. The inclusion shown in Figure 4c was identified with the SEM spectrometer as MnS (Figure 4k). An array of MnS inclusions or troughs can be seen in Figure 4e measuring from 0.003 inch to 0.005 inch. Dimpled rupture, void formation, and some cleavage is observed in Figures 4g and 4h. Lastly, typical elongated fine dimples are seen on the shear lip (Figure 4j).

Six of the eight tensile fracture surfaces examined showed that the fracture initiated at the specimen surface. Further, in four of the six specimens, the initiation was caused by the intersection of an inclusion with the surface.

6. Erratic and poor short transverse ductility is caused by the random intersection of the specimen surface with MnS inclusions.

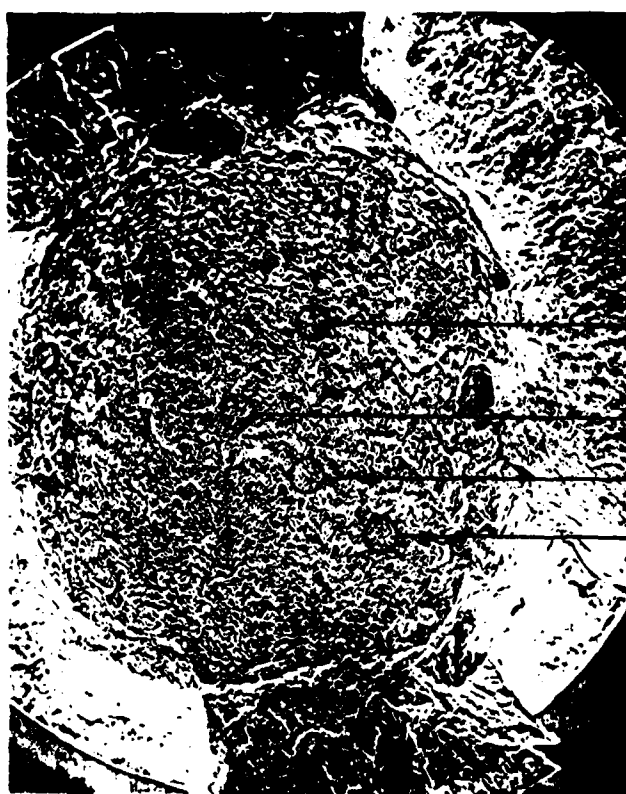
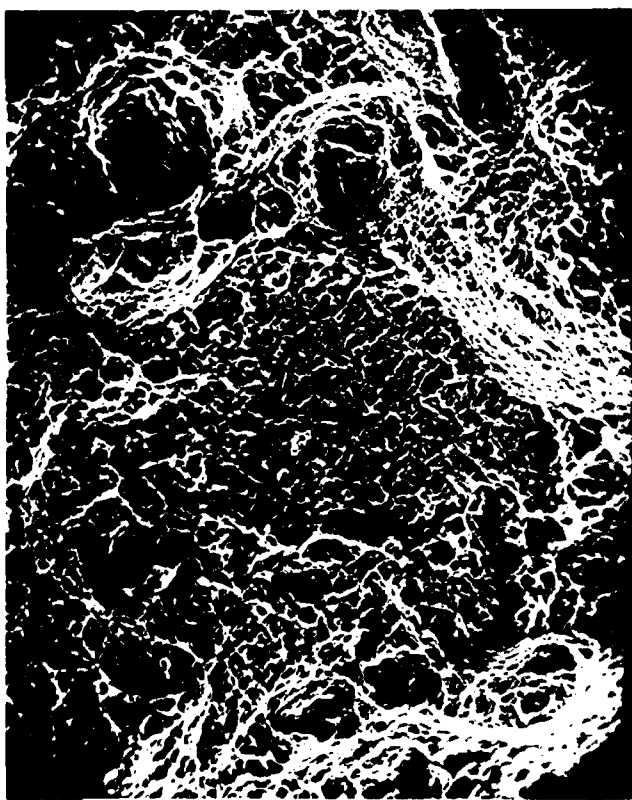
Figure 5. SEM short transverse tensile fractographs - heat treated in air. ESR 300M, short transverse.

Fractographs of the fracture surface of a specimen machined in the short transverse orientation from material heat treated in an air furnace are shown in Figure 5. The specimen had a 29 percent reduction-of-area at fracture. The tensile fracture originated at the center with radial propagation to the final separation by ductile shearing. The central area is shown in Figure 5a with an enlargement in Figure 5b showing an inclusion surrounded by dimples. Figures 5c and 5d show an area containing large voids which have coalesced. Pores and voids are visible in Figures 5e, 5f, and 5g. Some evidence of quasi-cleavage and dimples can be seen in Figure 5h.

Heat treatment in air or vacuum had no effect on the fracture surface morphology of short transverse tensile specimens that exceeded minimum ductility requirements. Significantly, more elongated inclusions with evidence of quasi-cleavage were observed in the fractures initiating at the surface in specimens heat treated in air and having poor ductility.

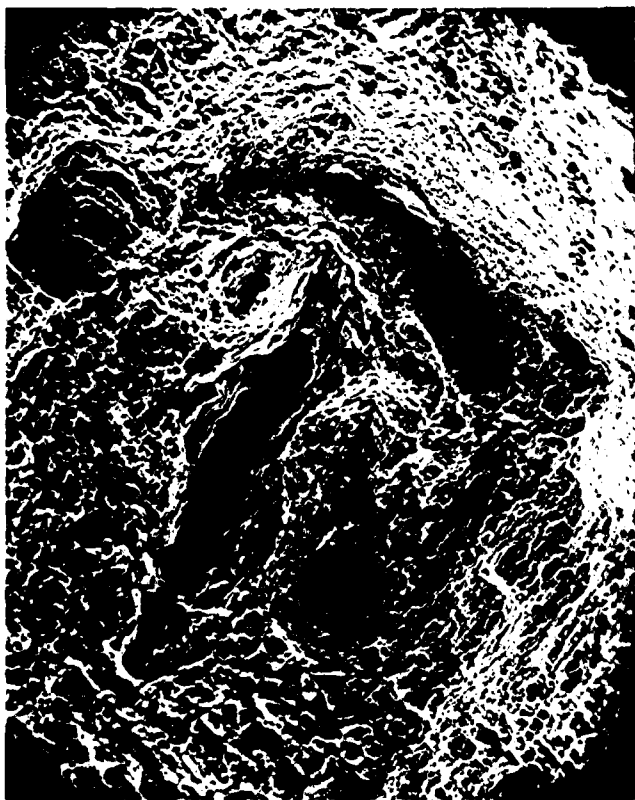
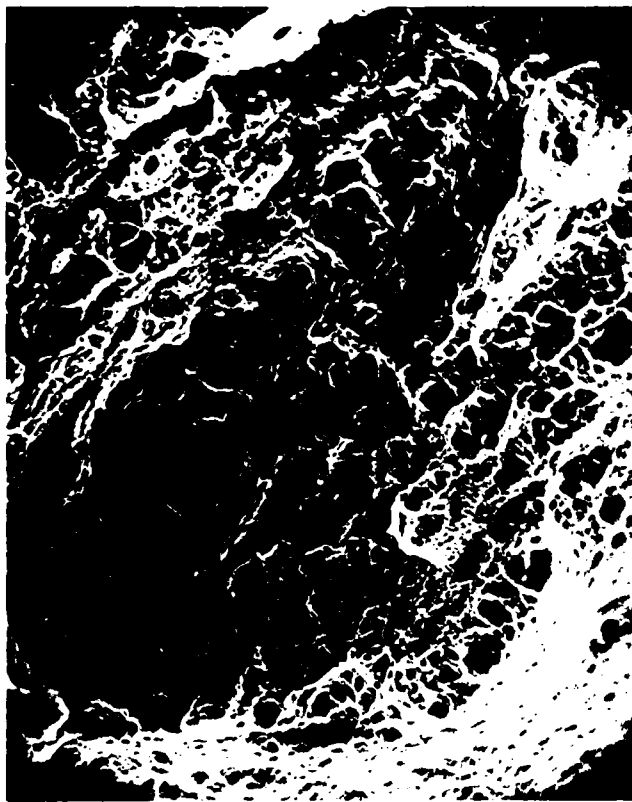
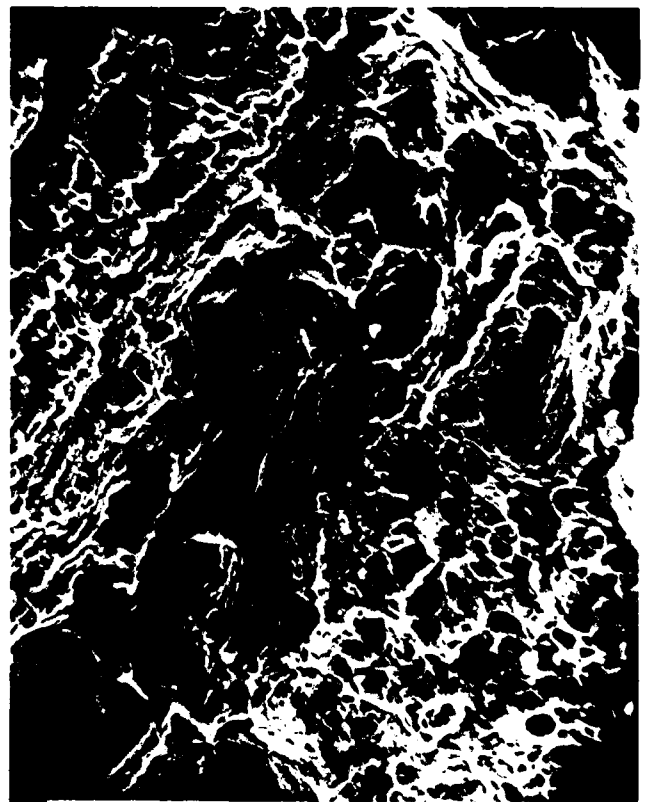
Figure 6. SEM short transverse tensile fractographs - heat treated in vacuum. ESR 300M, short transverse - Vac. H.T.

SEM micrographs of a specimen having 33 percent reduction-of-area and heat treated in vacuum are shown in Figure 6. The fracture, which initiated internally, has radial markings and is separated by ductile shearing. The fracture appearance was rougher than its companion specimens heat treated in air. Large pores and voids can be seen in the initiation zone (Figures 6a and 6b). An inclusion initiated pore can be seen in Figures 6c and 6d. Fracture progressed by microvoid coalescence as evidenced in Figure 6e, 6f, and 6g. Figure 6 shows an inclusion surrounded by an immediate zone of quasi-cleavage giving way to dimpled rupture.

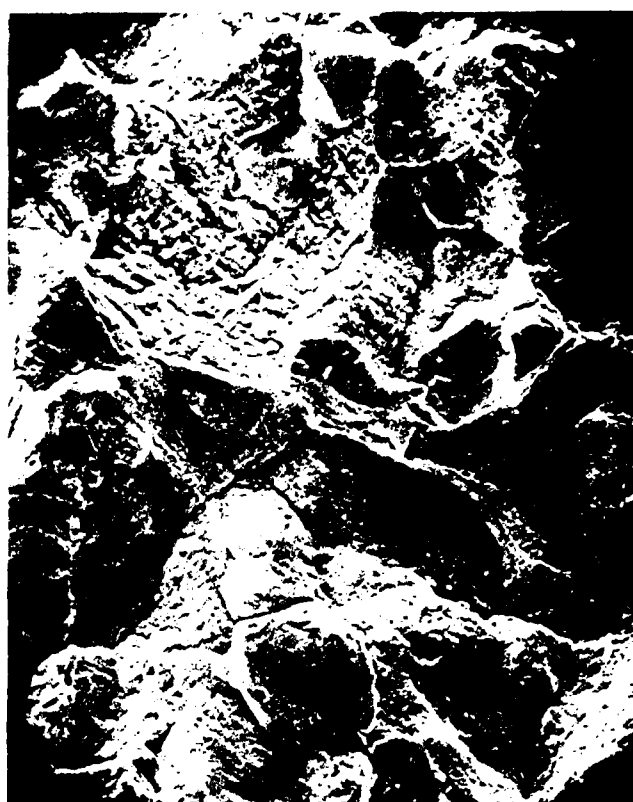
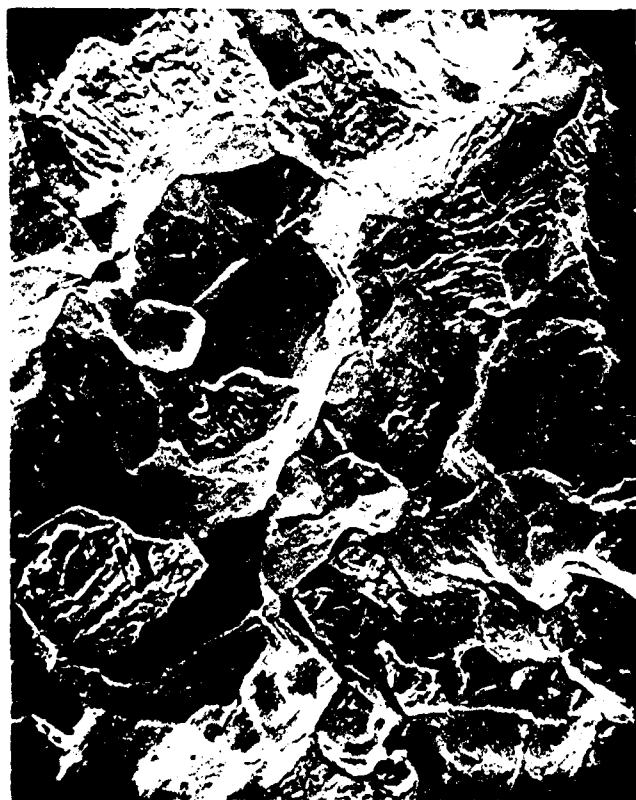
Figure 7. Stress corrosion cracking, ESR 300M.

SEM photographs of fracture surfaces of longitudinal (L-T) K<sub>ISCC</sub> specimens are shown in Figure 7. The fracture mode evident in Figures 7a through 7c is intergranular. Figure 7d, taken from the fast fracture zone of the test specimen, shows a ductile or dimpled fracture mode.
